Field Report for Airborne Data Collected In Support of US EPA Region 6 Intercontinental Terminals Company LLC Fire 27 March 2019

ASPECT was requested to fly the tank farm, confluence and downwind areas on the morning of 27 March 2019. This report summarizes the findings of the mission.

Data Results Flight 14, 27 March 2019

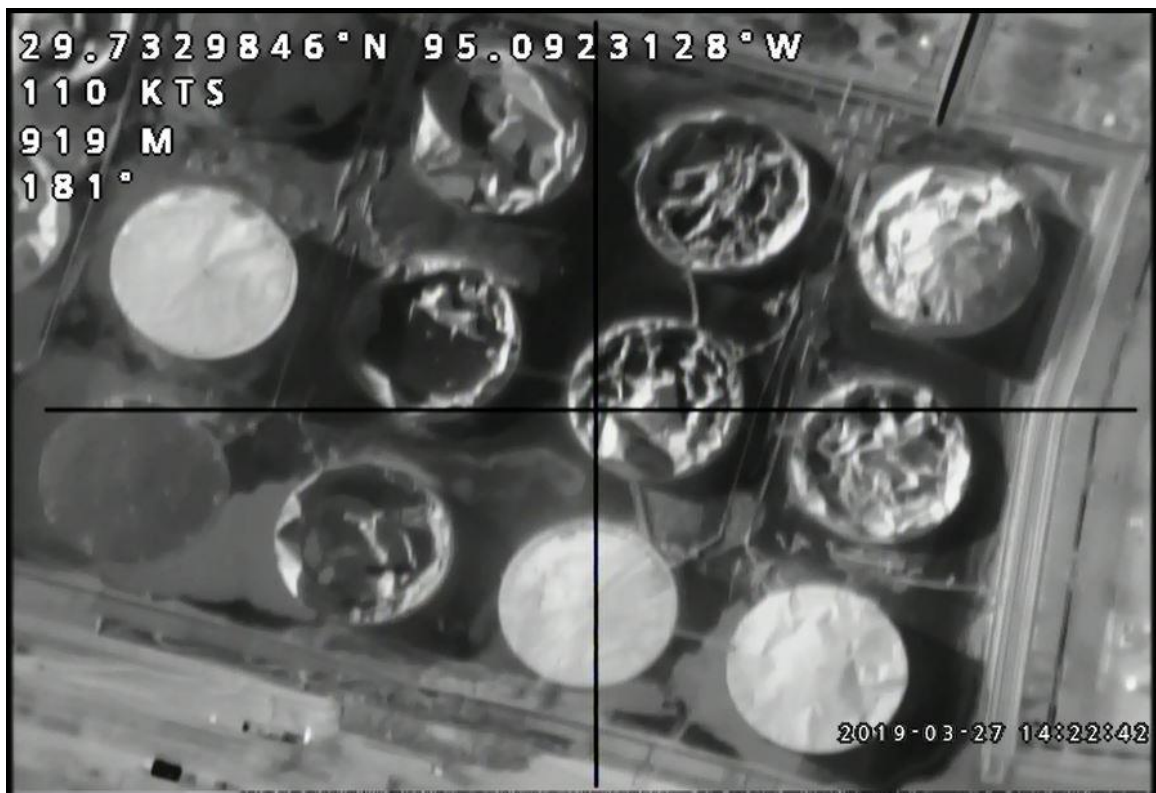
Figure 4: IR Thermal Analysis 27 March 2019, Flight 14, Run 8

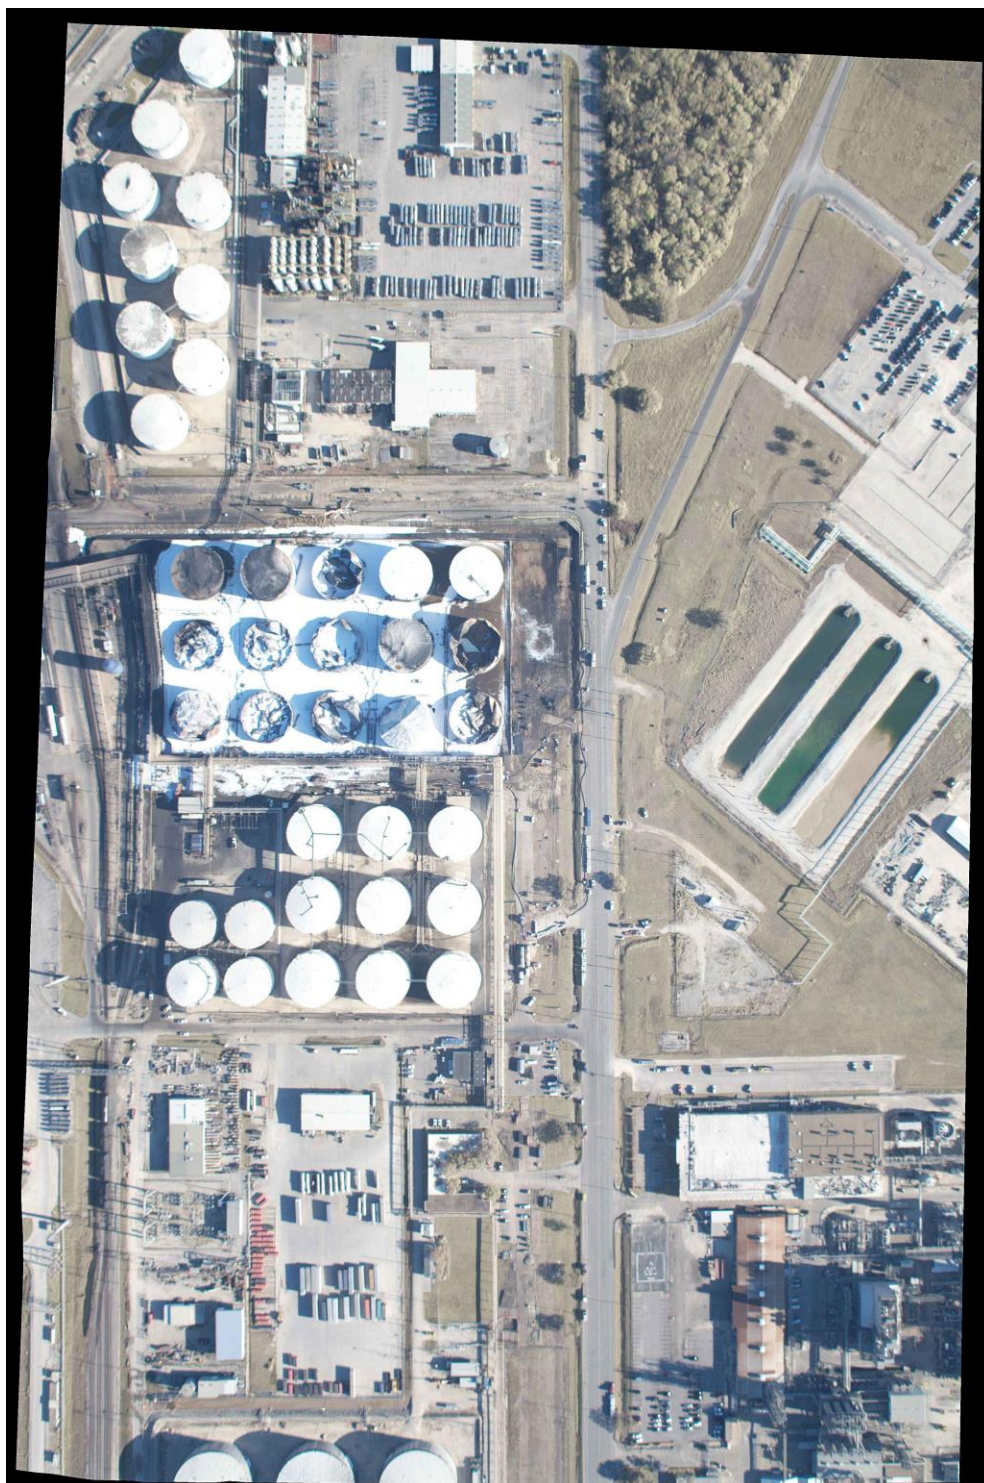
A full set of high resolution aerial digital photography was collected as part of the flight. Figure 7 shows a representative overhead image collected as part of each pass over the tank farm. There is effectively little new information that can be extracted for the tank farm. Figure 8 provides an overhead view of the confluence area. The amount of trapped product appears to be less than on prior missions. The image does not show boom leakage. The same area as viewed using the oblique camera shows more detail of the trapped product and does show some leakage from one boom layer to the next. Little leakage is evident from the main booms

Figure 6: Aerial Image of the Tank Farm, 27 March 2019, Flight 14
